November 11, 2019

Re: Response to USEPA Request for Information
Docket No. CWA-308-R01-FY-19-32
Discharge of Sulfuric Acid
Barnhardt Manufacturing Company
247 Main Road, Colrain, MA
MassDEP RTN 1-20919
OEG Project No. 3958

Barnhardt Manufacturing Company, 247 Main Road, Colrain, MA – Photo Log

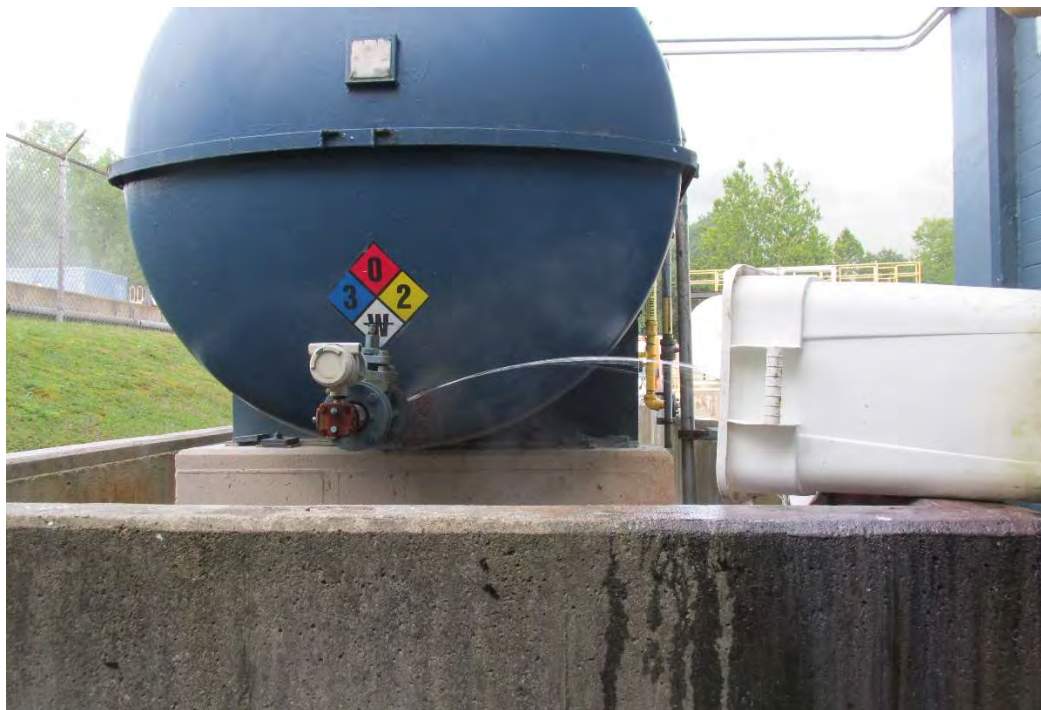
- *Upon arrival at approximately 6:10 A.M., the WWTP operator found a breach on the eastern side of the AST that measured approximately one-quarter inch in diameter. Due to head pressure inside the AST, sulfuric acid was spraying into a plastic container that re-directed the acid into secondary containment. A sand berm was present inside the drainage swale that appeared to have stopped the acid from reaching the Tailrace Brook. Sodium bicarbonate was then used to neutralize acid that had reached the drainage swale. The WWTP operator then conducted a visual inspection of the concrete apron stormwater structure that drains to the Tailrace Brook, which is located at the eastern extent of the drainage swale and at that time, the acid had not appeared to have reached the water. The spreading of baking soda onto the rocks close to the water, which showed no reaction, led BMC personnel to believe that no acid had made it to the water of the Tailrace Brook.*

- Sulfuric acid was released from the failure of a bead weld on supply piping near the eastern base of the 4,500-gallon AST. Due to head pressure, the released acid “sprayed” over the concrete containment structure onto surficial soils located immediately south of the Screen Building/east of the concrete containment structure. From this point, some of the acid was retained in soils, and a portion of the acid migrated easterly atop soils (approximately 3-feet wide over 25 linear feet) and then continued easterly via a bituminous paved stormwater swale (approximately 2-feet wide over 15 linear feet) to the concrete apron stormwater discharge. From this area the acid discharged to the Tailrace Brook and flowed southerly approximately 465 feet to the confluence with the North River. Inspection by MassDEP of the confluence of the North River and Deerfield River (approximately 2.2 miles from the confluence of the Tailrace Brook and North River) revealed pH reading between 7 and 8 and the release condition is not believed to have impacted surface waters beyond the North River. Subsequent observations by other involved parties (as referenced herein) further confirm that impacts resulting from the discharge were restricted to the Tailrace Brook and North River.*

- *Based on BMC observations on September 1, 2019, the probable cause of the spill has been attributed to the failure of a bead weld on the supply piping exiting the eastern base of the subject AST.*

Photo 1 Spray of Sulfuric Acid from AST (9/1/2019).

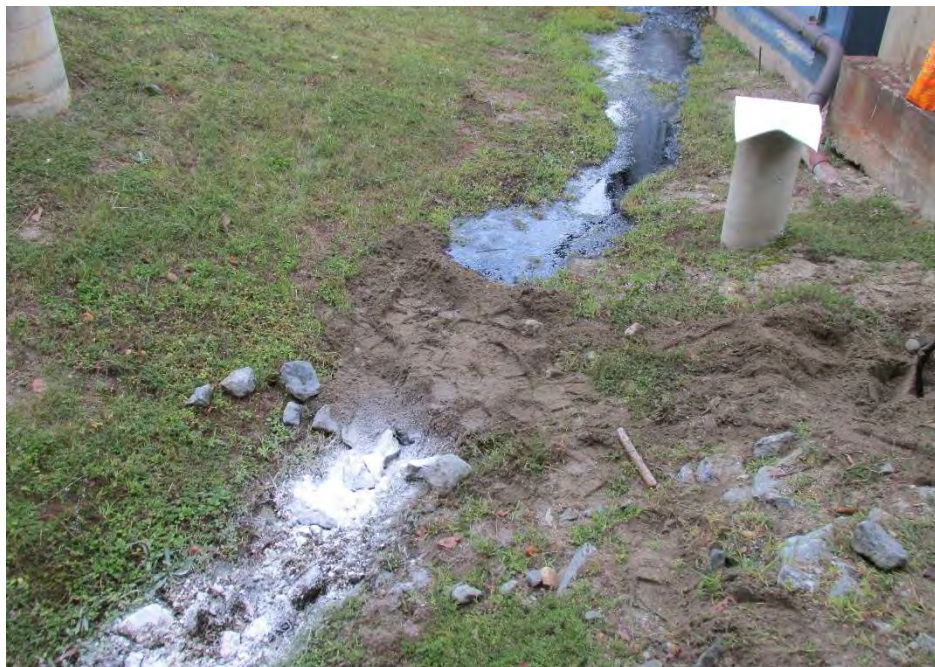
- *The release condition resulted in stained soils, vegetation and paved surfaces between the eastern limits of the concrete containment structure to the concrete apron stormwater outfall to the Tailrace Brook. These areas were neutralized, and impacted materials were removed. A fish kill was subsequently identified in the Tailrace Brook and North River. Photographs of the release condition, remedial actions and restoration are presented in [Attachment-3](#).*

Photo 2 Sulfuric Acid impacts leading within the drainage swale (9/1/2019).

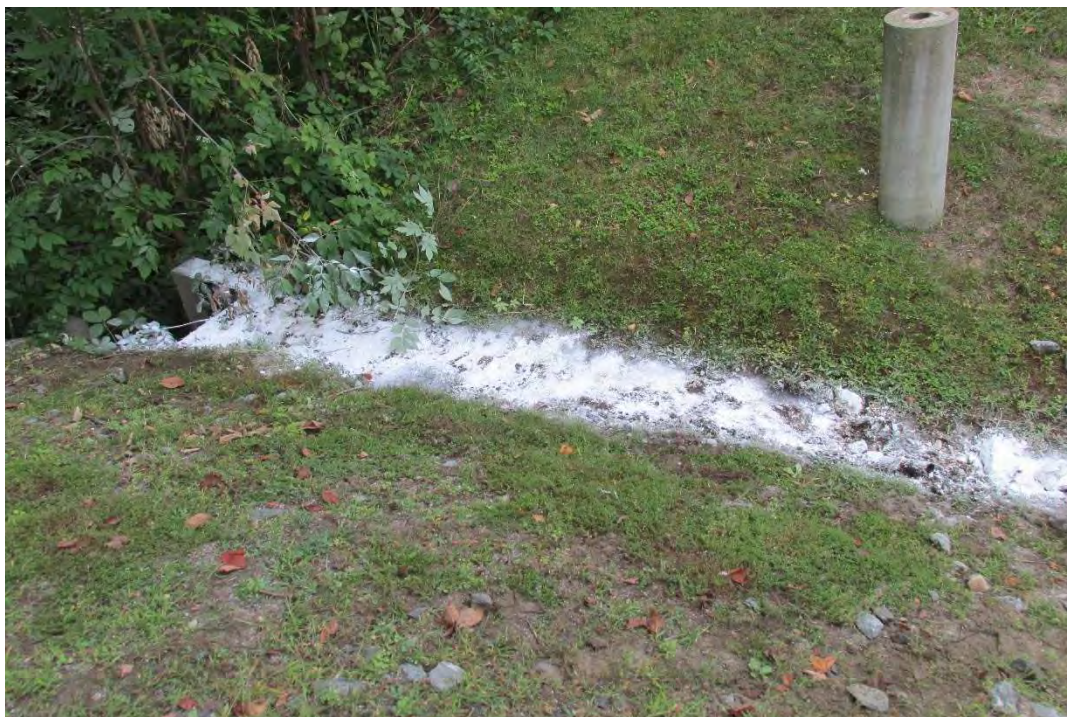
- *According to observations made by the night and day shift boiler operators, the release condition had made it to the concrete apron of the stormwater swale leading to the Tailrace; however, there was only minimal “wetness” to the concrete apron. BMC personnel applied neutralizing agent to the vertical face of concrete apron and rock outfall to the Tailrace Brook and the expected reaction with an acid (e.g. bubbling, fizzing and misting) was not observed. As a result, BMC personnel did not believe the Tailrace Brook had been impacted as that portion of the released acid not contained migrated only so far as the concrete apron.*

Photo 3 Sulfuric Acid impacts leading up to the Tailrace (9/1/2019).

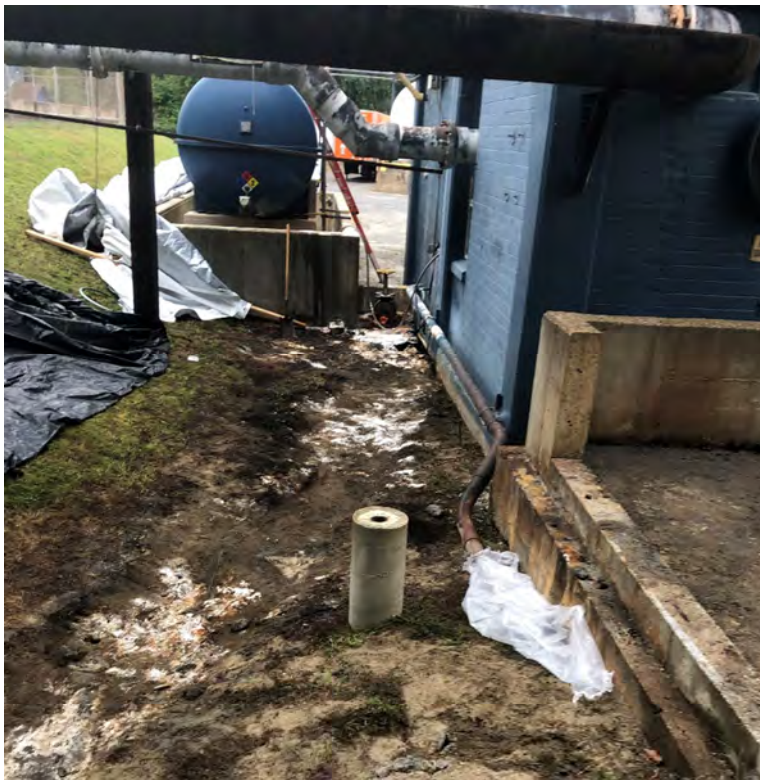
Photo 4 Eastern end of the former AST. Southern wall of the Screen building. Looking West (9/4/2019).

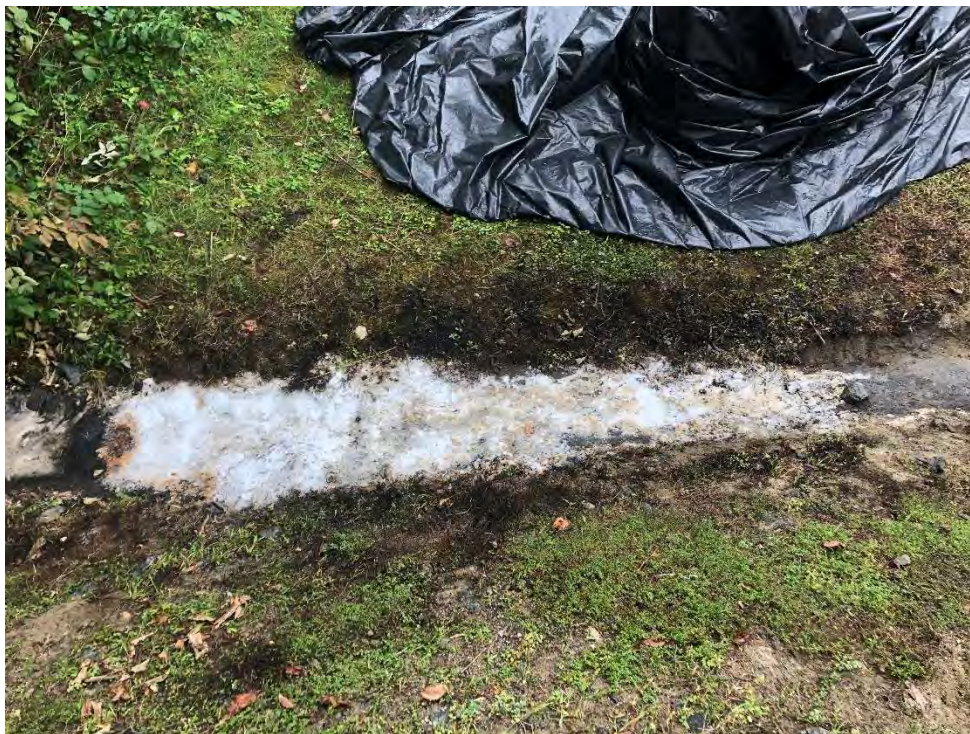
Photo 5 Eastern end of the drainage swale near the outfall. Looking south. Note the sodium bicarbonate (9/4/2019).

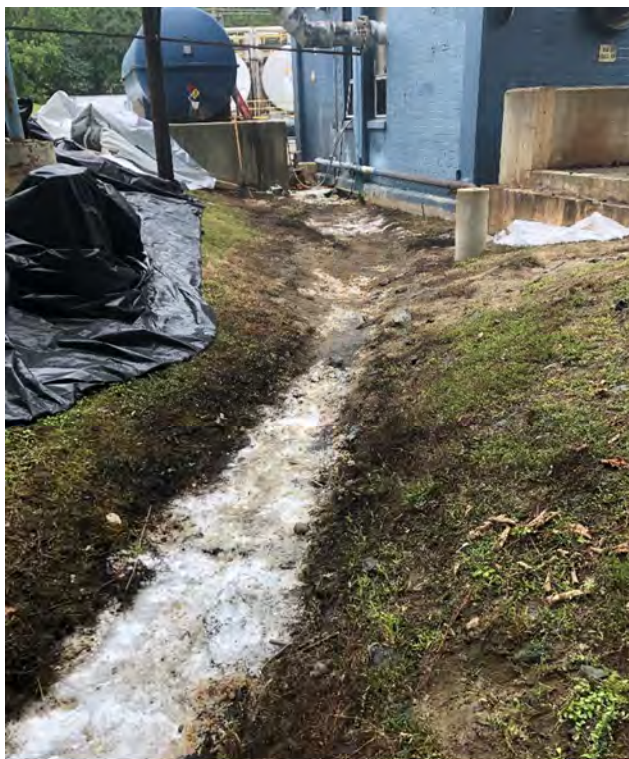
Photo 6 Eastern end of the drainage swale looking west. Note the sodium bicarbonate (9/4/2019).

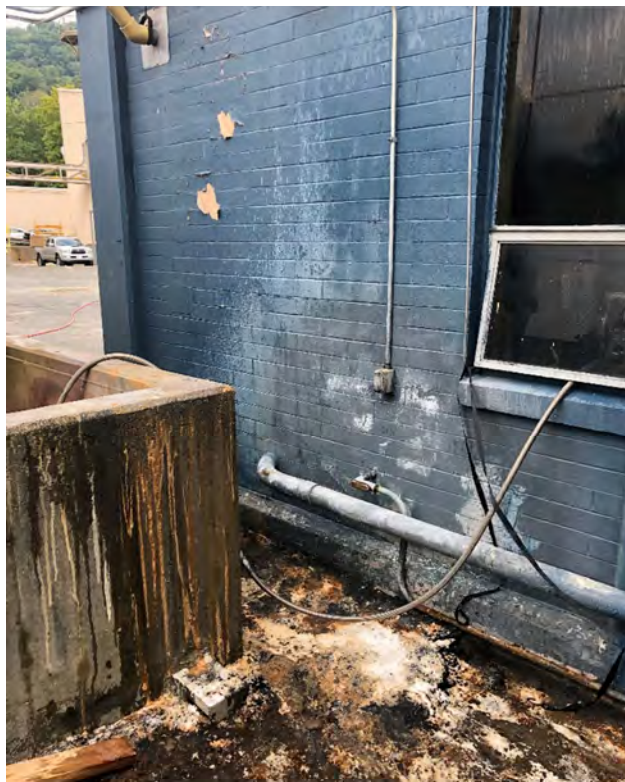
Photo 7 Eastern end of former containment dike. Southern wall of the screen building (9/4/2019).

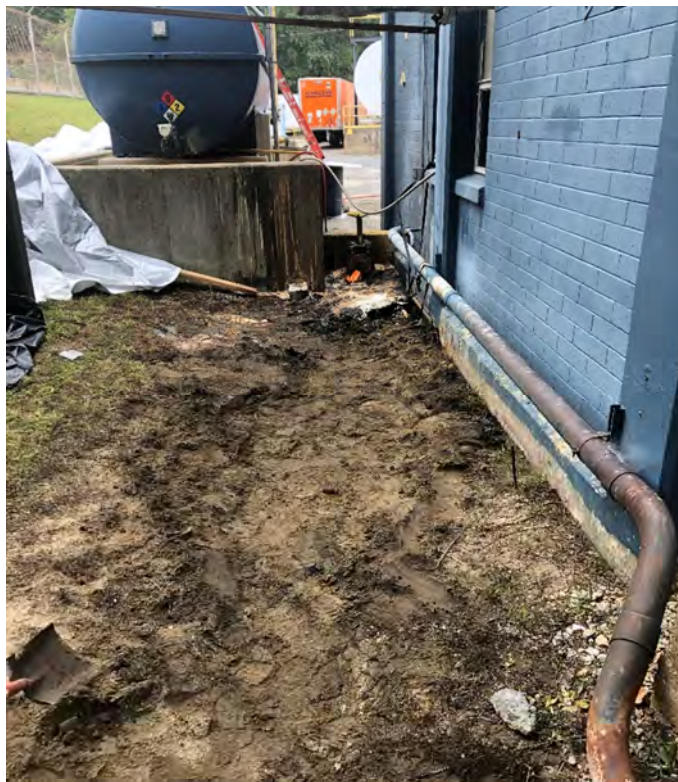
Photo 8 Drainage swale looking west towards the tank. Note the limited excavation (9/4/2019).

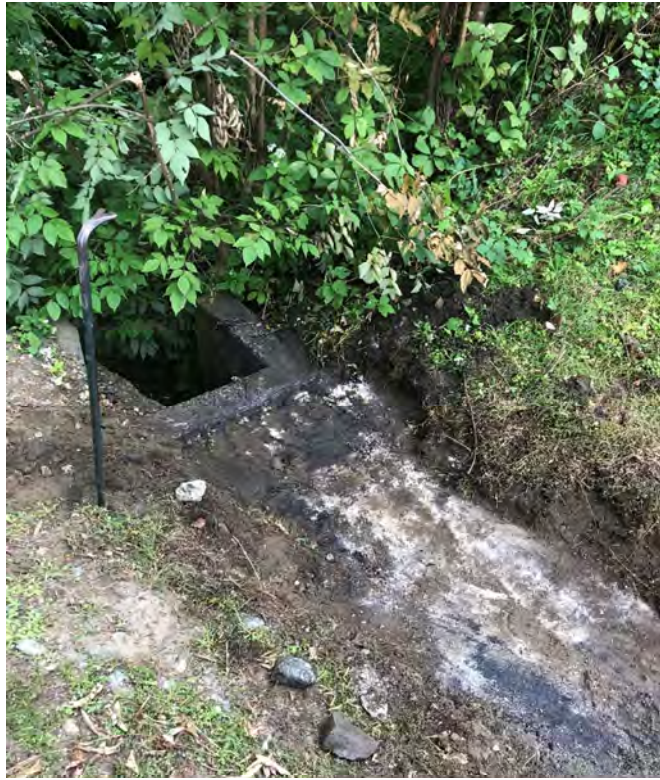
Photo 9 Eastern end of the drainage swale and discharge outfall to the Tailrace (9/4/2019).

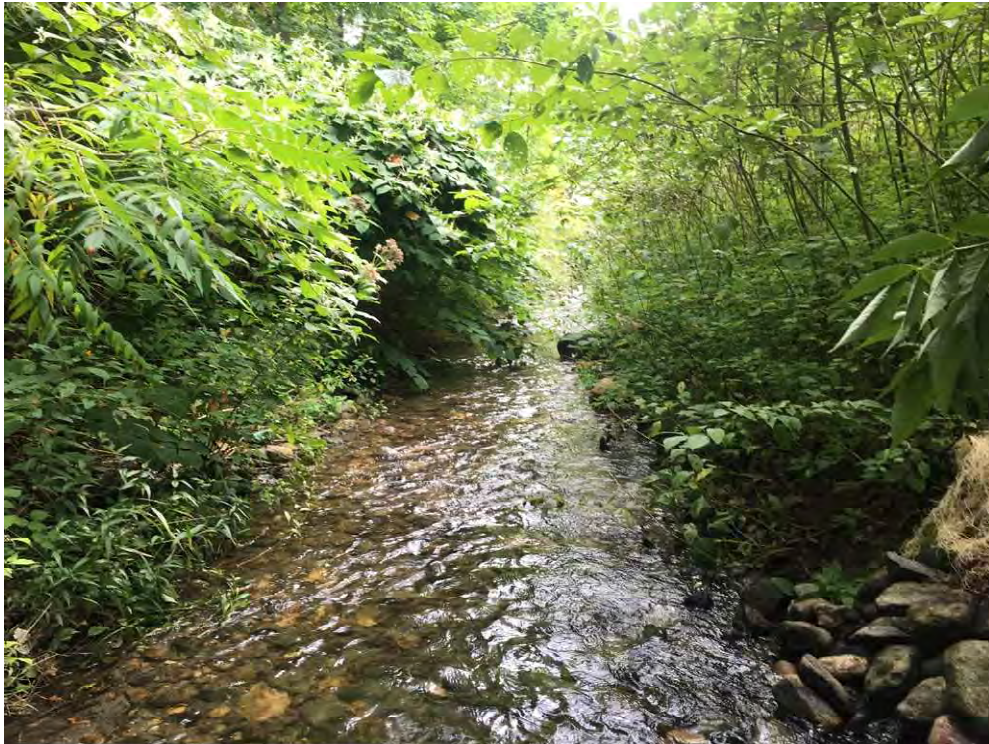
Photo 10 Tailrace looking south towards the North River (9/5/2019)

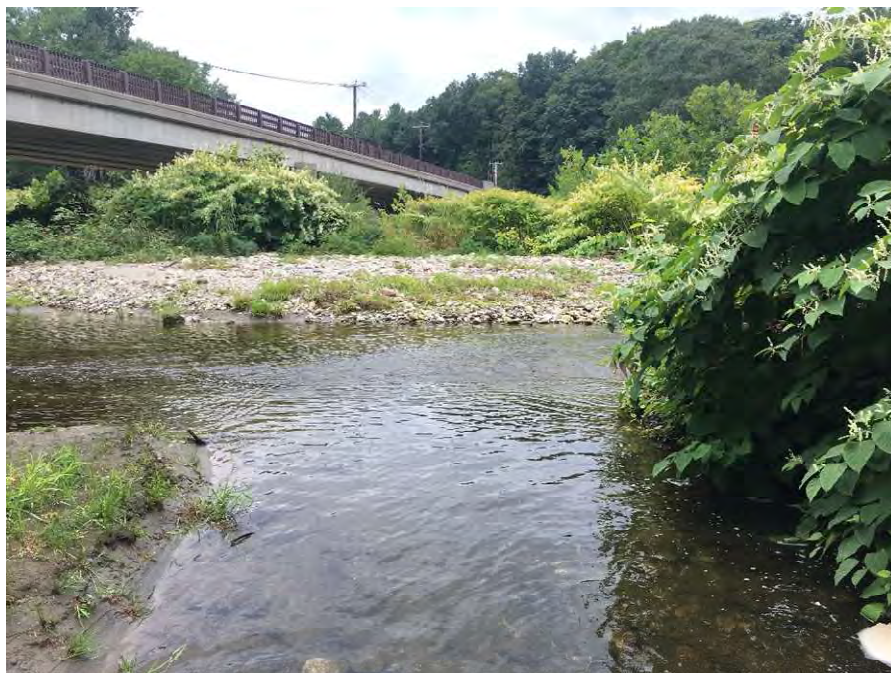
Photo 11 Confluence of the Tailrace and North River (9/5/2019).

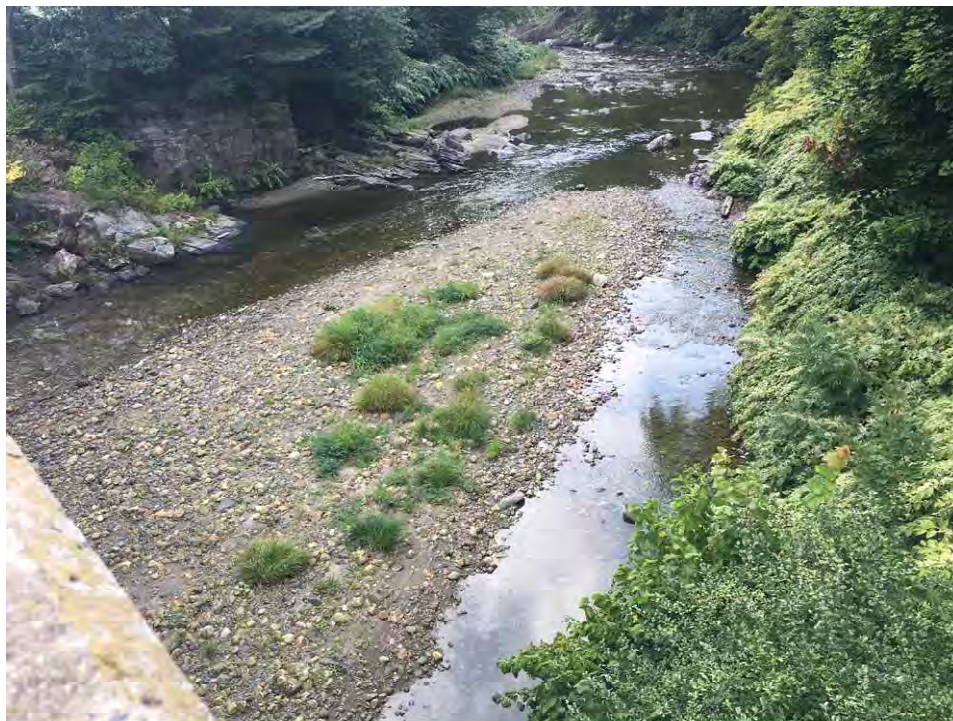
Photo 12 View of the North River looking South (9/5/2019).

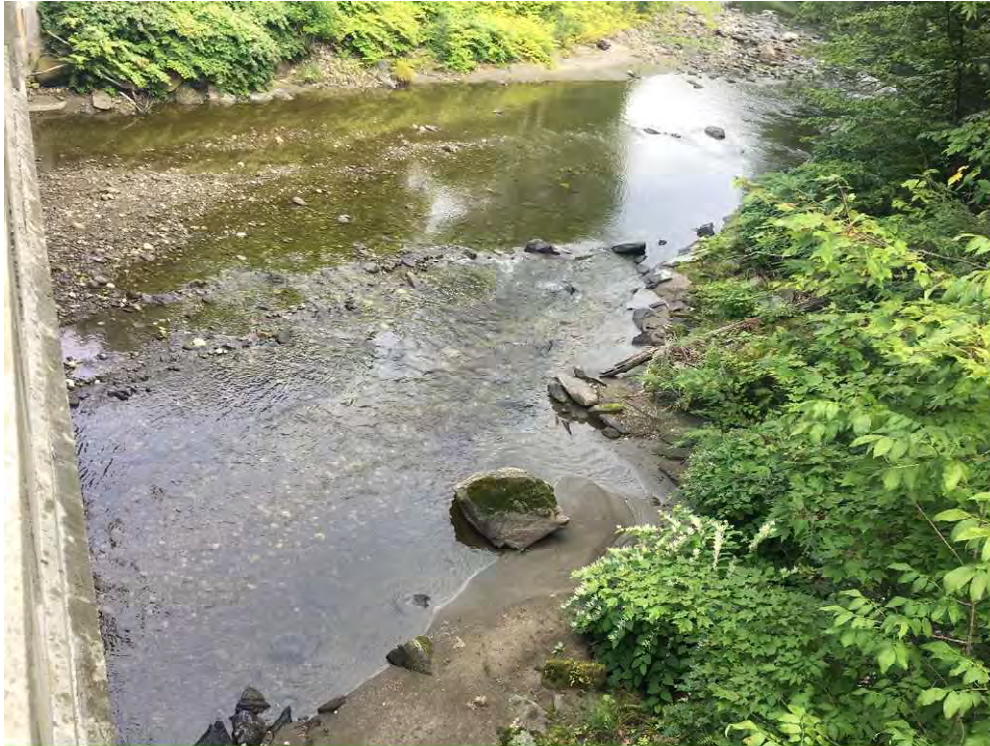
Photo 13 View of the North River looking South (9/5/2019).

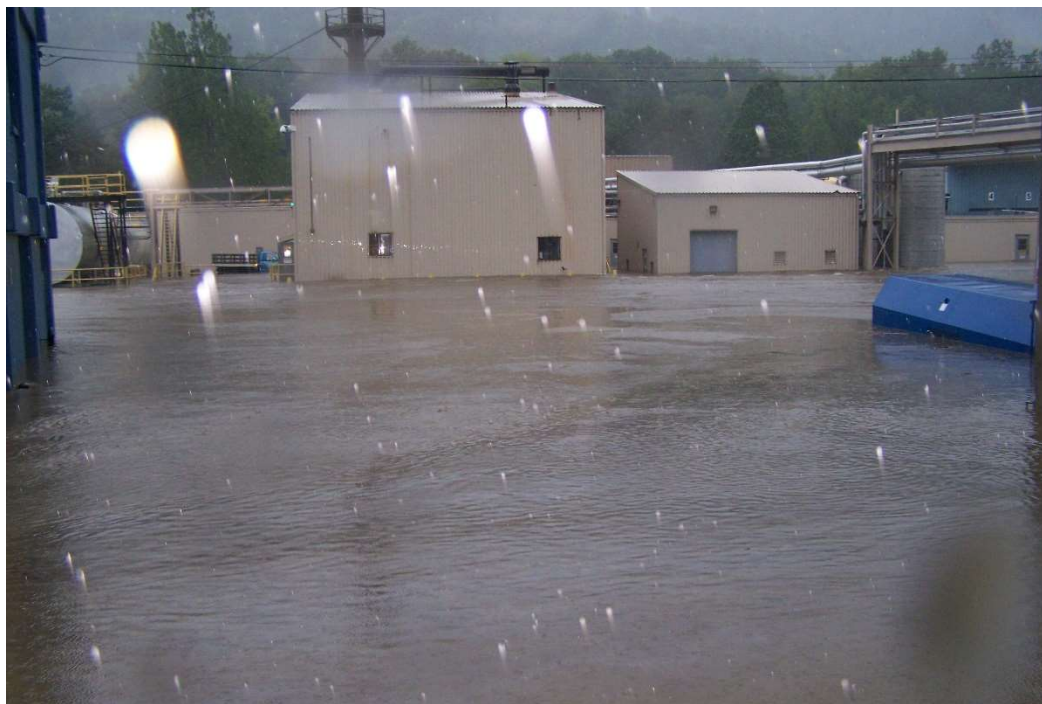
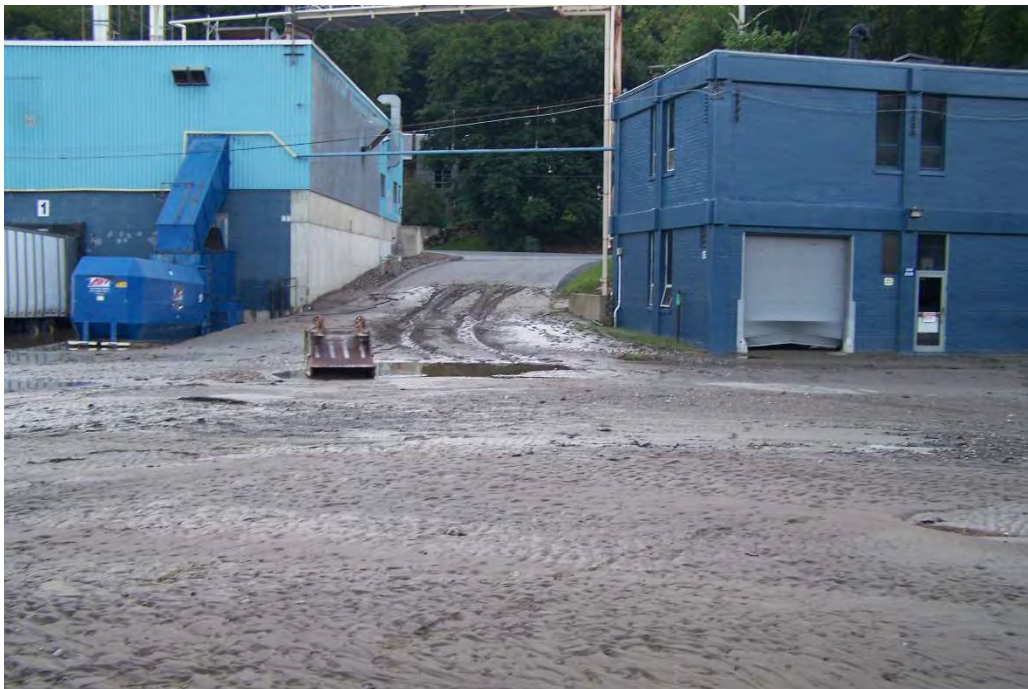
Photo 24 Flood Waters during Hurricane Irene (August 2011).

Photo 26 Flood Waters during Hurricane Irene (August 2011). Note the Screen Building on the right.

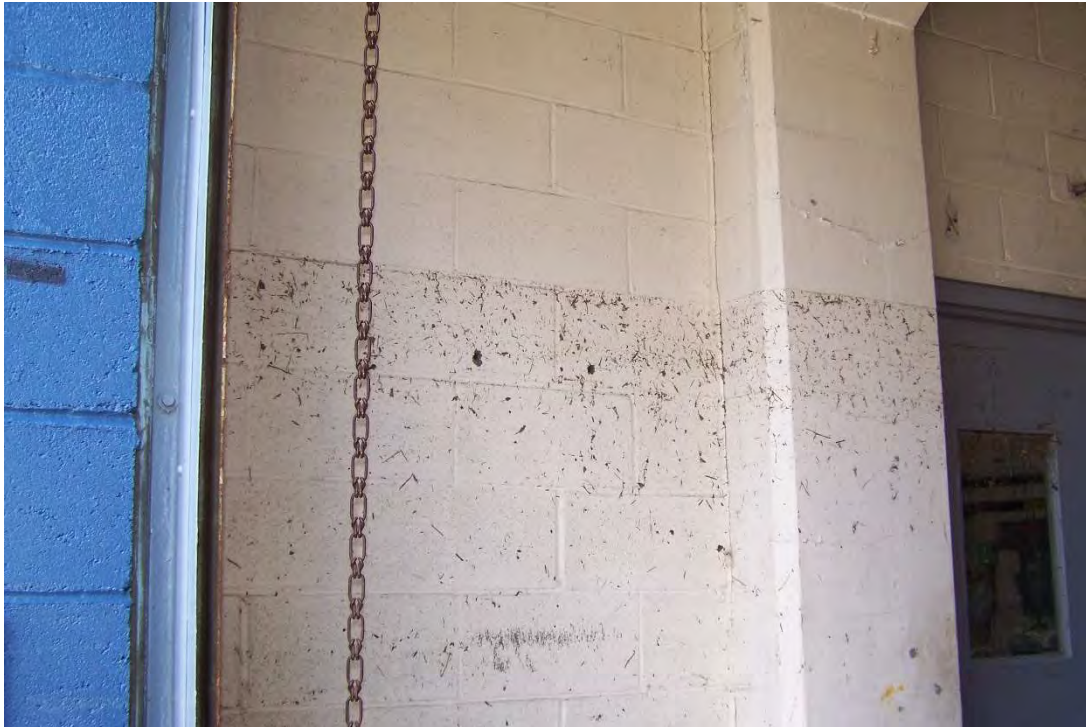
Photo 25 Highwater mark of Hurricane Irene floodwaters (August 2011)

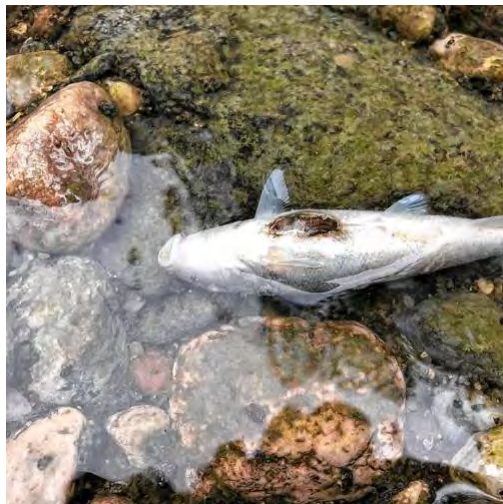
A sulphuric acid leak reportedly was the cause of a fish kill in North River on Sunday. Contributed photo
